TESTS OF REINFORCED CONCRETE FLAT SLAB STRUCTURES

BY
ARTHUR N. TALBOT
And
WILLIS A. SLATER

BULLETIN No. 84
ENGINEERING EXPERIMENT STATION

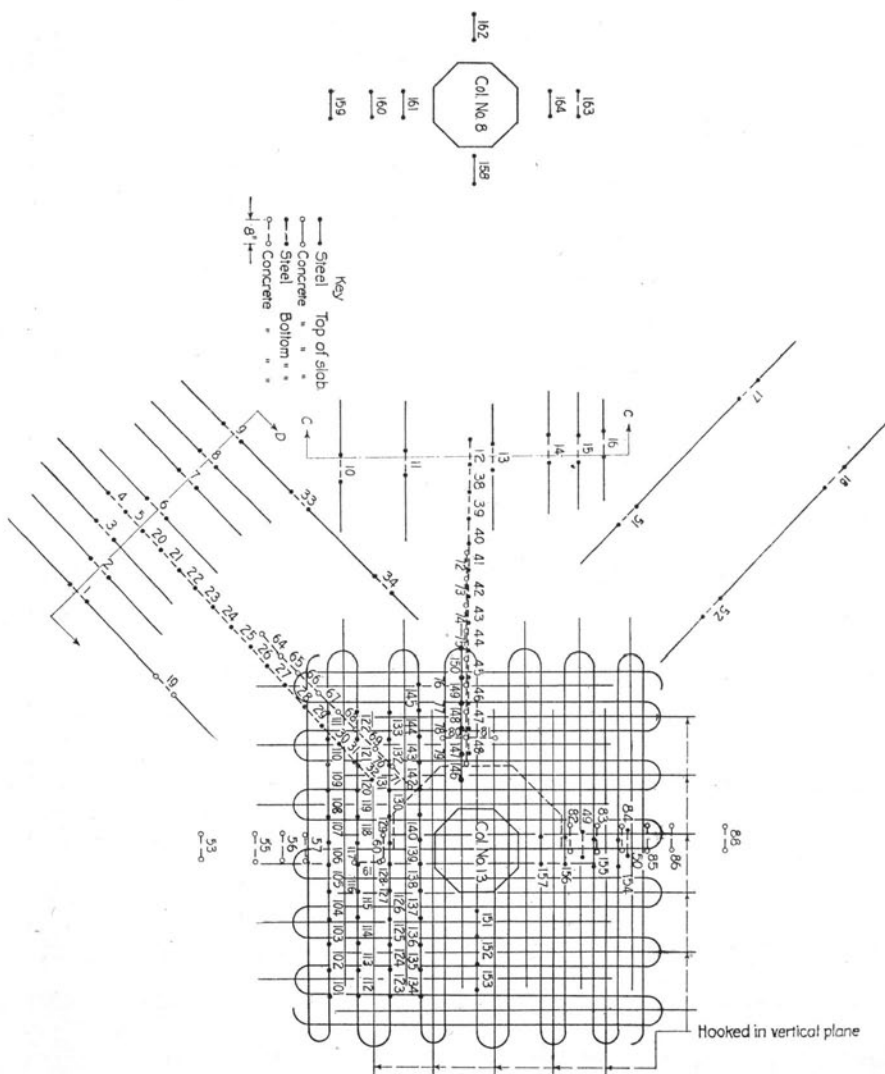
FIG. 78. LOCATION OF GAGE LINES ON UPPER AND UNDER SURFACES OF TEST FLOOR CURTIS-LEGER COMPANY BUILDING.

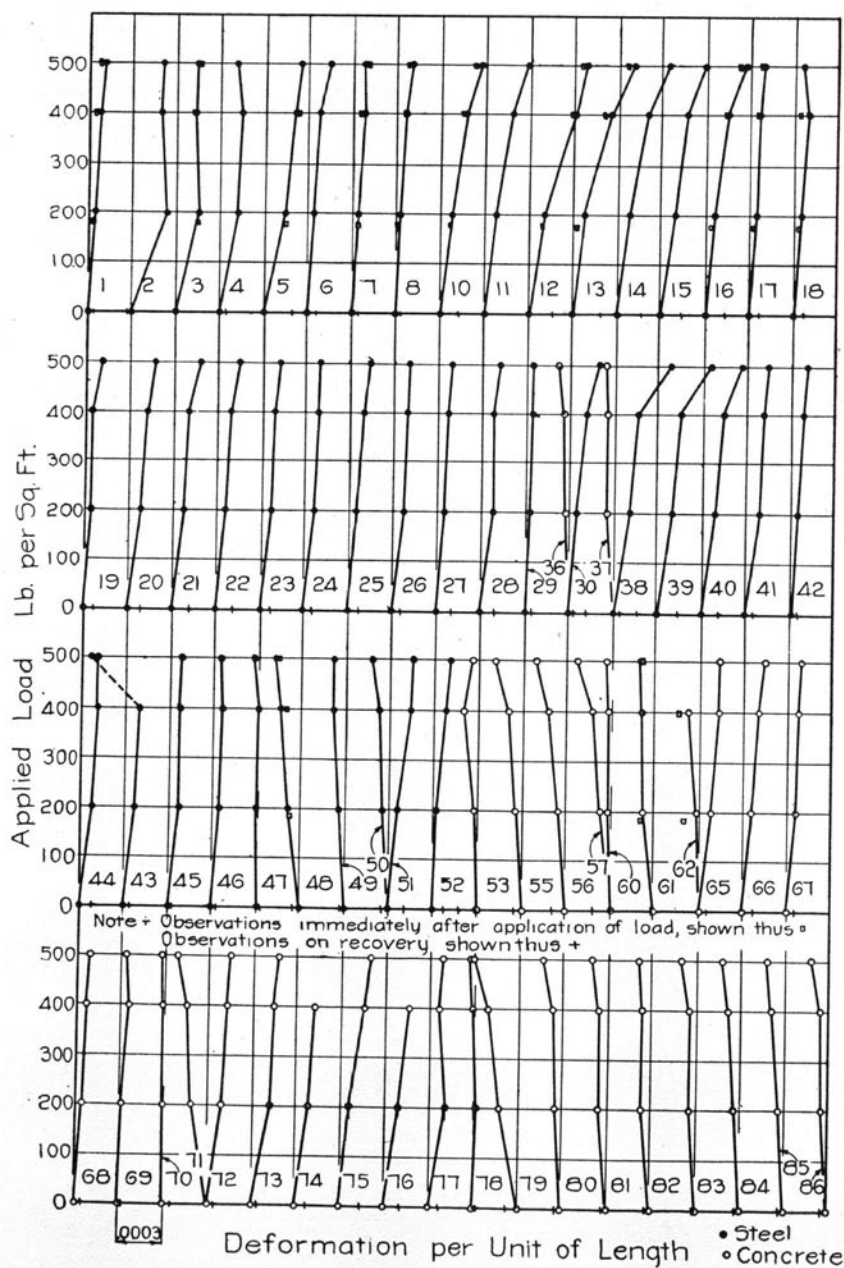
FIG. 79. LOAD-DEFORMATION DIAGRAMS FOR GAGE LINES 1 TO 86 OF TEST FLOOR OF CURTIS-LEGER COMPANY BUILDING.

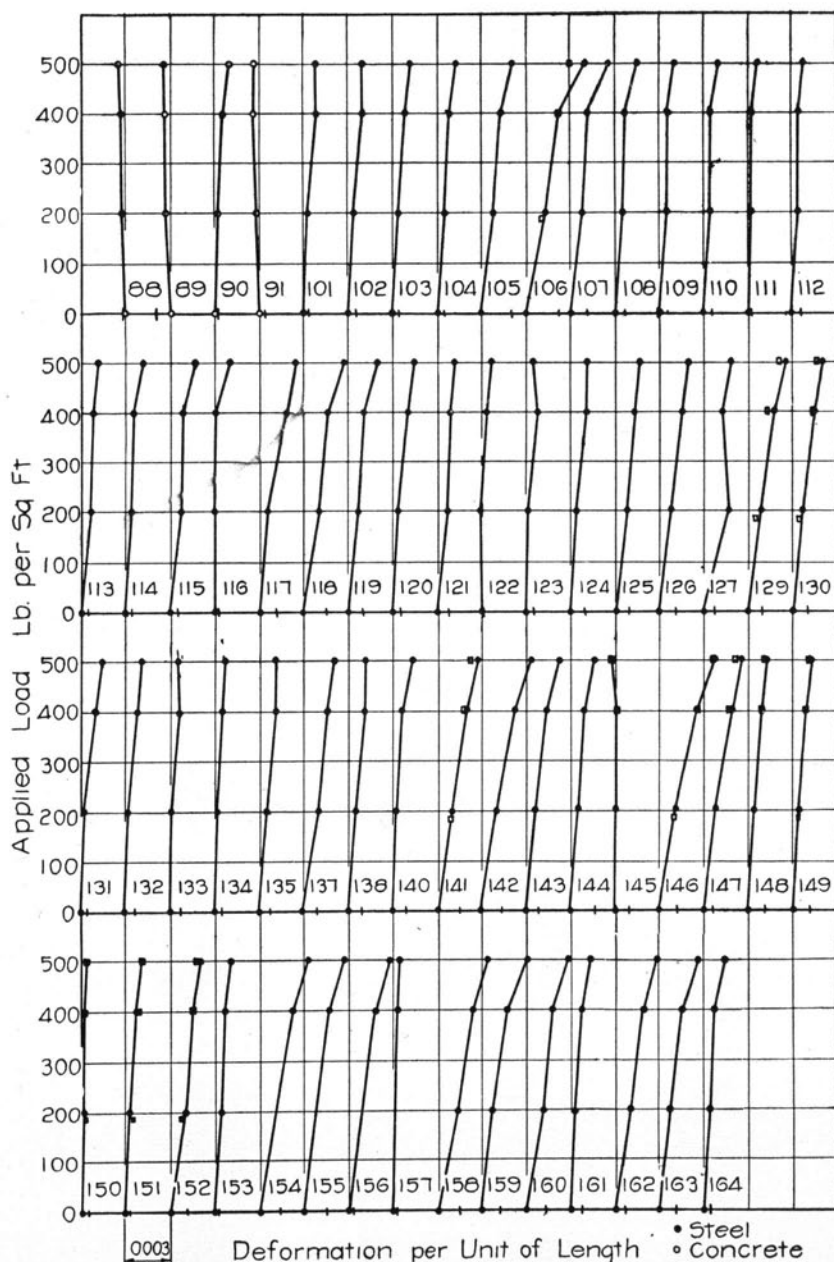
FIG. 80. LOAD-DEFORMATION DIAGRAMS FOR GAGE LINES 88 TO 164 OF TEST FLOOR OF CURTIS-LEGER COMPANY BUILDING.

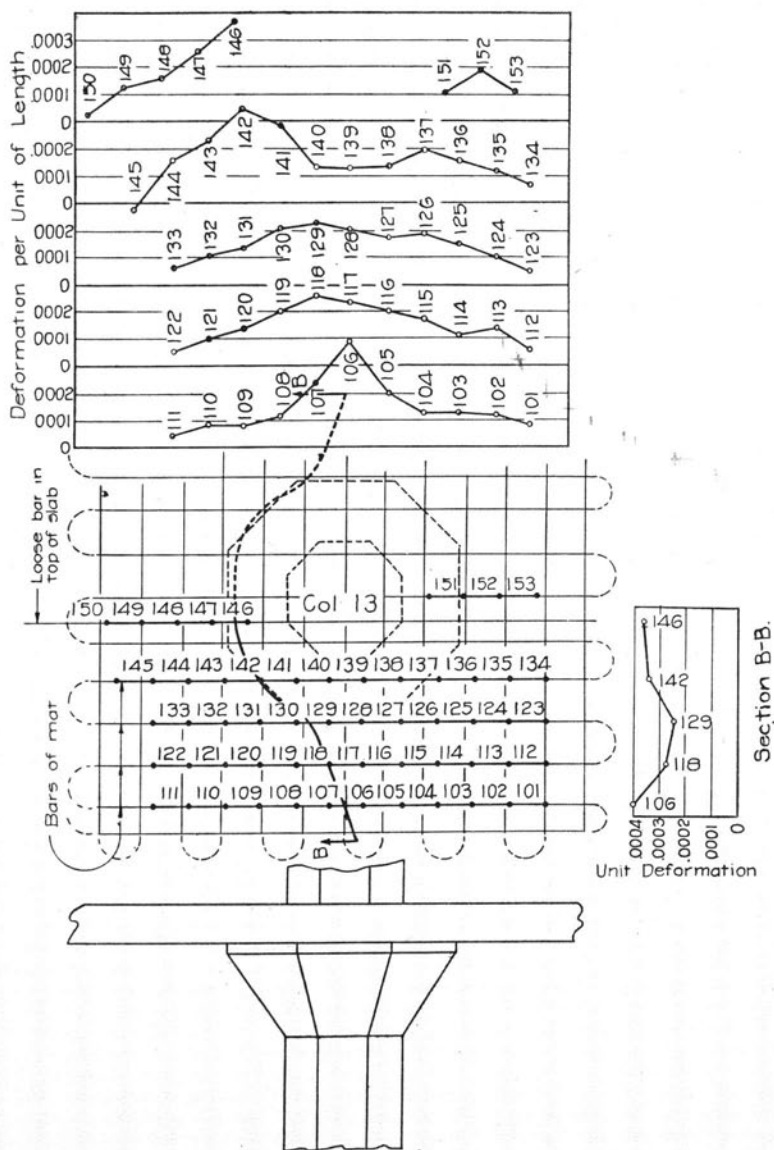
FIG. 81. LOCUS OF POINTS OF HIGHEST STRESS IN REINFORCEMENT IN TOP OF SLAB NEAR COLUMN 13 OF TEST FLOOR OF CURTIS-LEGER COMPANY BUILDING.

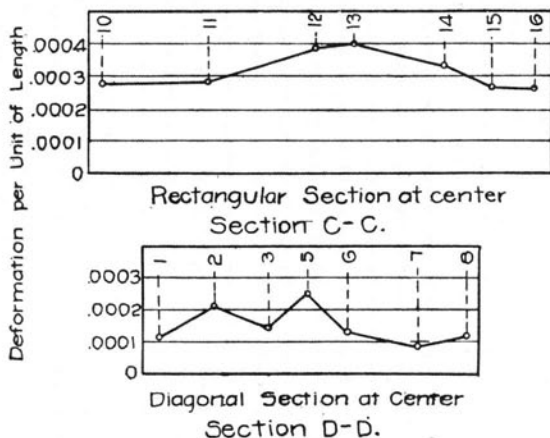
FIG. 82. TENSILE UNIT-DEFORMATION, MIDWAY BETWEEN COLUMNS, IN REINFORCEMENT OF RECTANGULAR AND OF DIAGONAL BANDS IN TEST FLOOR OF CURTIS-LEGER COMPANY BUILDING.

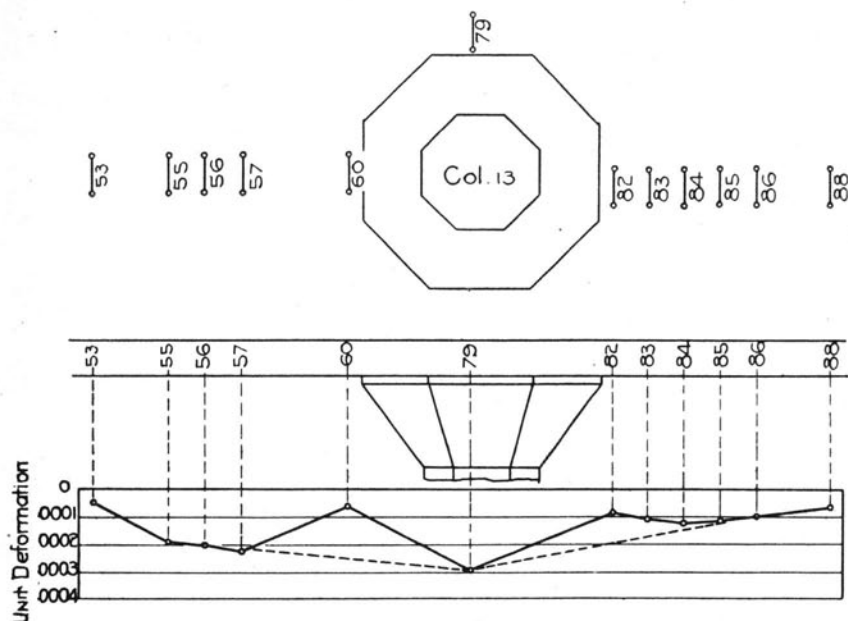
FIG. 83. LATERAL DISTRIBUTION OF COMPRESSIVE DEFORMATION ON BOTTOM OF TEST FLOOR OF CURTIS-LEGER COMPANY BUILDING.

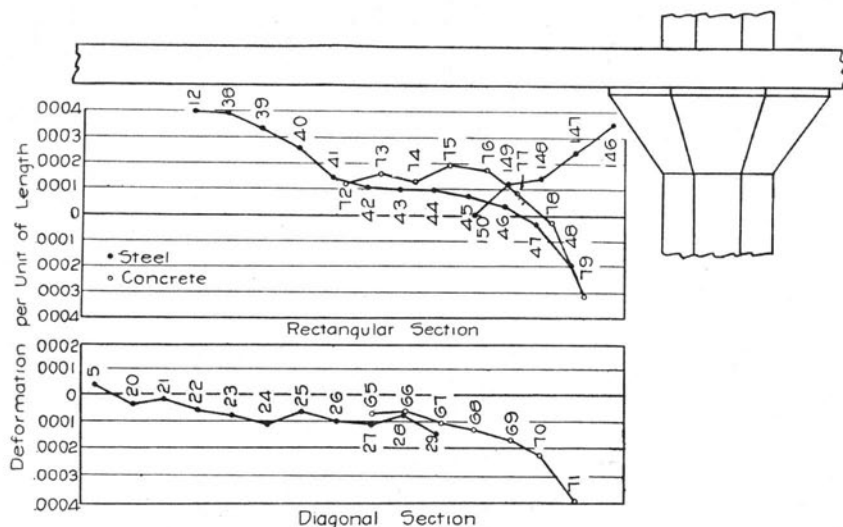
FIG. 84. LOCATION OF POINTS OF ZERO UNIT-DEFORMATION ON UPPER AND UNDER SURFACES OF TEST FLOOR IN CURTIS-LEGER COMPANY BUILDING.

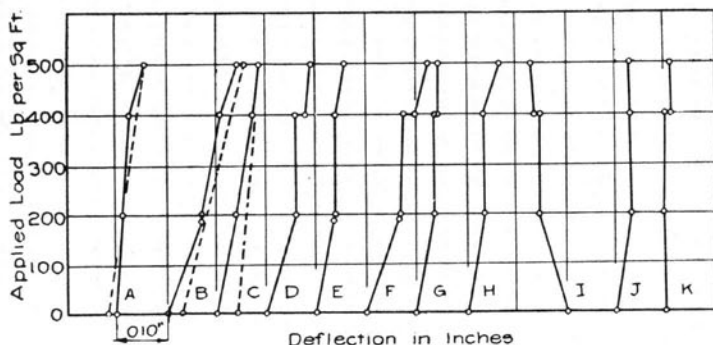
FIG. 85. LOAD-DEFLECTION DIAGRAMS FOR TEST FLOOR OF CURTIS-LEGER COMPANY BUILDING.
